EXPERIMENTAL EVALUATION OF TWO 36" x 47"
GRAPHITE/EPOXY SANDWICH SHEAR WEBS

Harold G. Bush

August 27, 1975

NATIONAL AERONAUTICS AND SPACE ADMINISTRATION
LANGLEY RESEARCH CENTER, HAMPTON, VIRGINIA 23665

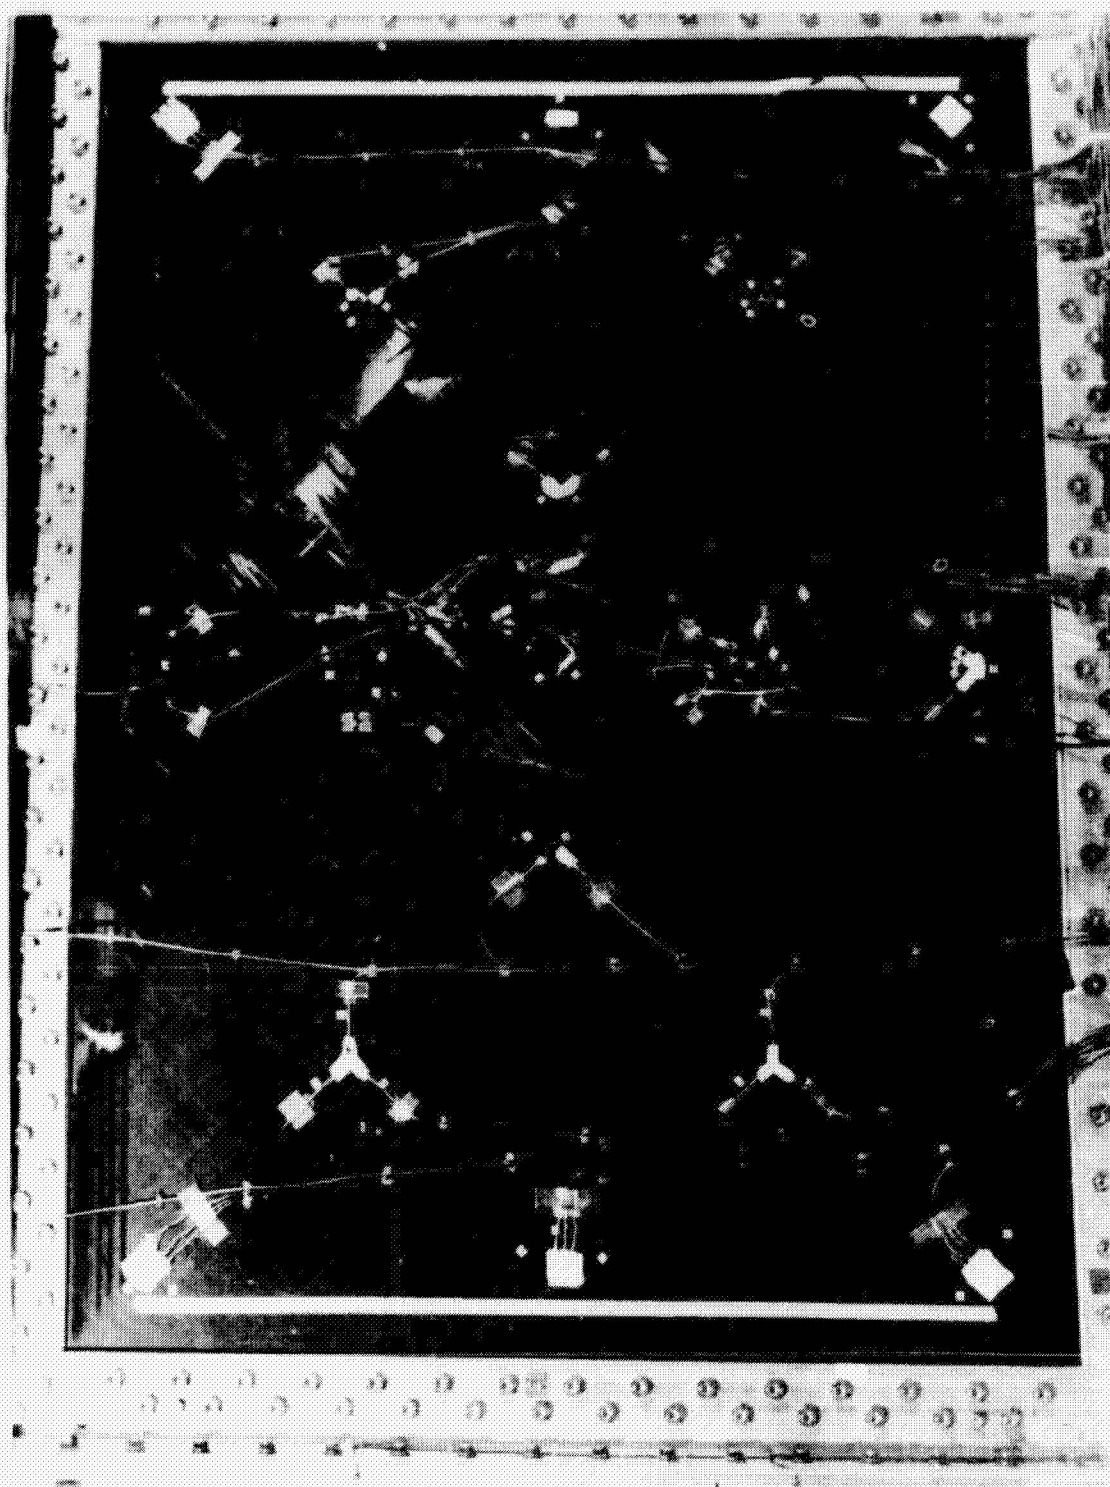
Figure 11(b).—Strength critical shear and after test (Side A).

The strength critical shear web was loaded to failure, which occurred at 434 kips. The failed shear web is shown in figures 11(a) and 11(b). Failure is suspected to have initially occurred at a point approximately 13" from the center attachment angle and approximately 7" from the top attachment angle because both compression and tension cracks appear to have run from this region to the panel edges. Moire fringe photographs did not show any discernible lateral displacement at failure. Back to back strain gages showed maximum deviations which were less than approximately $\pm 5\%$ from their respective membrane values, indicating that lateral bending was not a significant contributor to failure of the web. Figure 12 shows the $\pm 45^\circ$ strain response from rosettes which surround the central region of the test web. Horizontal and/or vertical strains from these rosettes were sufficiently small that the $\pm 45^\circ$ strains were, in essence, principal values. Thus, the shearing strain magnitude is the sum of the absolute values of principal strain shown in figure 12. Selecting an average value of each strain component at maximum load shows the average value of membrane shearing strain over a large portion of the web to be approximately equal to .0086 in/in just prior to failure.

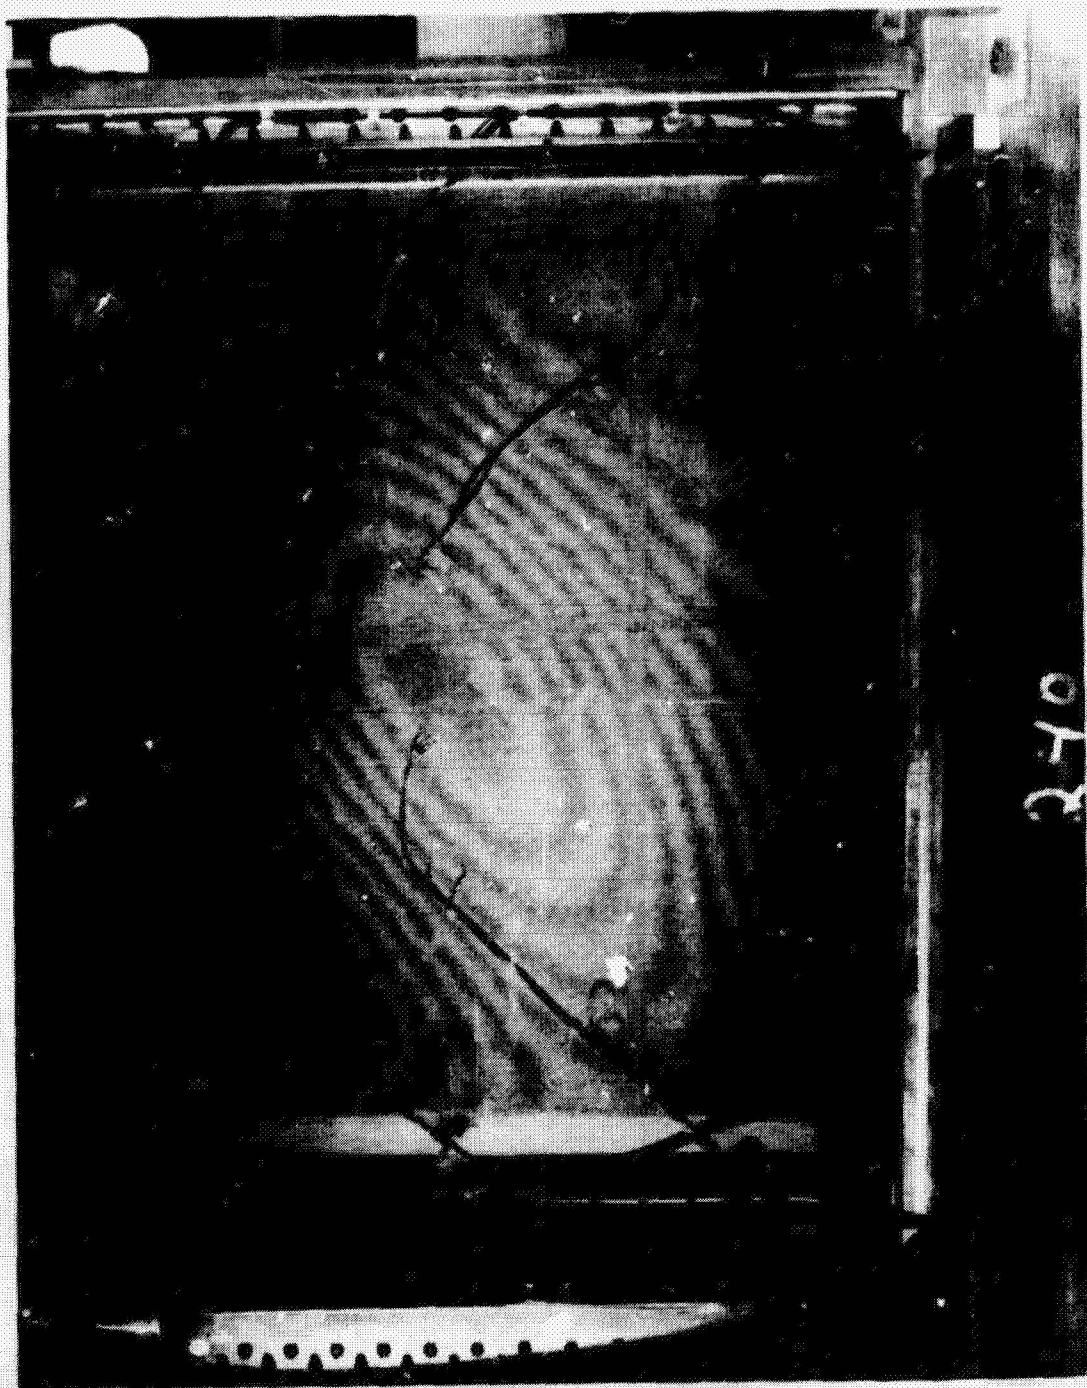
Figure 19.- Stability critical shear web during test (Moiré photograph at 240 X 10³ - Side B).

The moire fringe technique of observing lateral displacements was used to identify the buckling mode shape. Photographs were taken throughout the tests of the changing fringe pattern.
